**SITE CHARACTERISATION OF THE WHATAROA VALLEY
FOR THE DEEP ALPINE FAULT DRILLING PROJECT STAGE 2 (DFDP-2),
WEST COAST, NEW ZEALAND.**

Degree of Master of Science in Engineering Geology

University of Canterbury

Andrew Paul Klahn

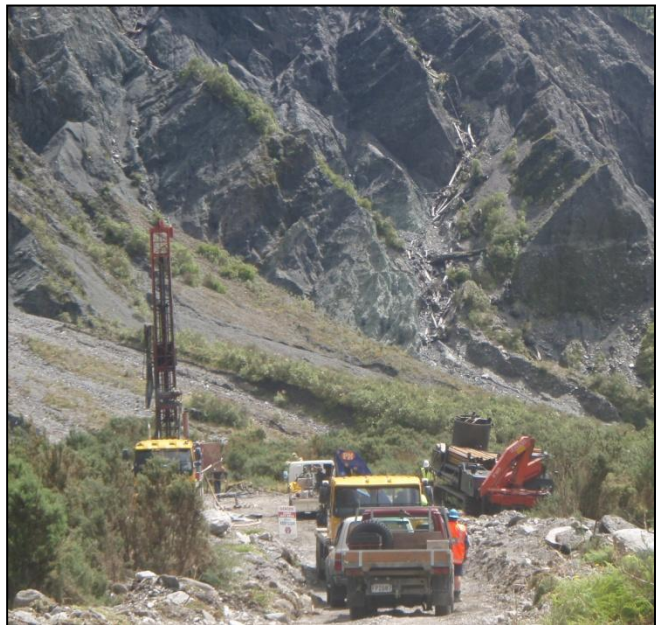
Figure 1.5 Drilling operations at Gaunt Creek for DFDP-1, with the well known and studied Alpine Fault outcrop in the background

To date, the first stage of the DFDP has been successfully drilled with two boreholes completed at Gaunt Creek, south of Whataroa. DFDP-1A was drilled to 100.6m and DFDP-1B to 151.4m. Wireline logging of the boreholes has been carried out with a wide range of tools such as natural gamma, calliper, electrical resistivity, spontaneous potential, density, porosity, full waveform sonic, dipmeter, and induction flow meter. Also, an observatory has been setup with a 2 Hz seismometer at the base of the hole, five piezometers to monitor pore fluid pressure, and 25 sensors to monitor the average temperature gradient in the borehole and detailed thermal structure immediately above the fault (Sutherland, 2011).

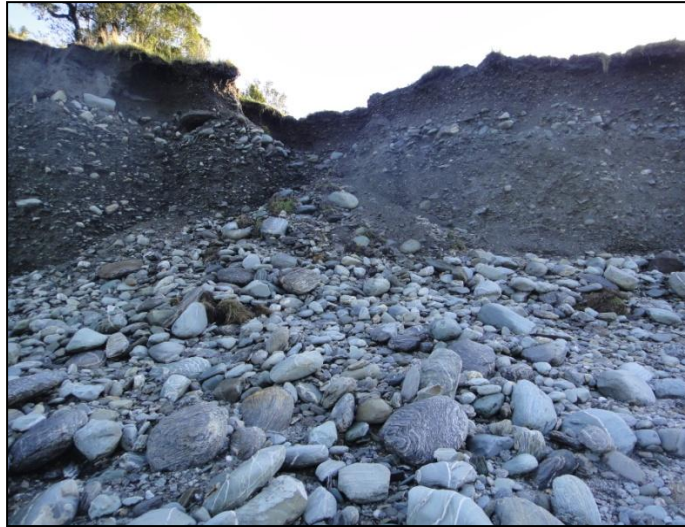
Figure 2.2 Failure of the 1717 Gravel unit.

The 1717 and 1620 gravel units have slight imbrications of the gravels, suggesting paleo flow directions into the gravel face, and there is a definite trend of fining upwards with a majority of the large boulders lining the bottom of the unit. These characteristics could suggest it was deposited relatively rapidly after a shaking event, as directly after an event is when there will be an abundance of large material, this would be the source of the large bouldery base of the units. Both the units are very loose with occasional large sand lenses within them, and they regularly have boulders and over hanging debris falling off and collecting at the base of the river bank as colluvium. Following completion of the facelog, there was a small failure of the 1717 gravel cliff face (Figure 2.2). This is the first instance of this happening in the last two years, it is not a regular feature of this unit and is likely due to high pore pressures built up during a storm combined with the water table from the nearby pond (Figure 2.3).

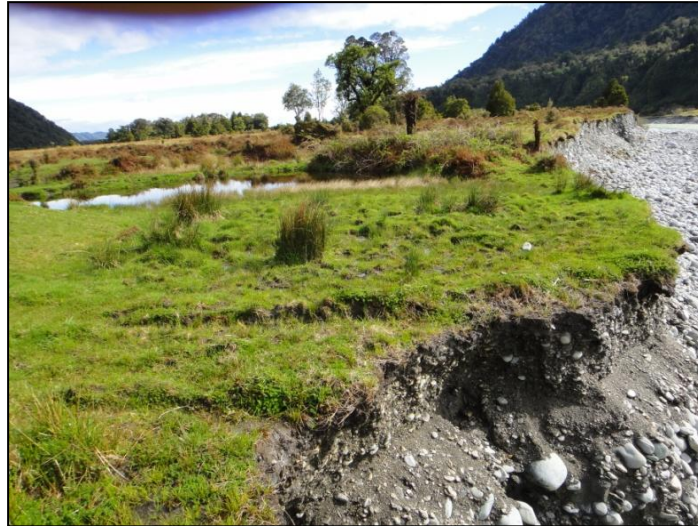
Figure 2.3 Pond possibly providing heightened pore pressures near the river bank edge where the 1717 AD gravel unit failed.

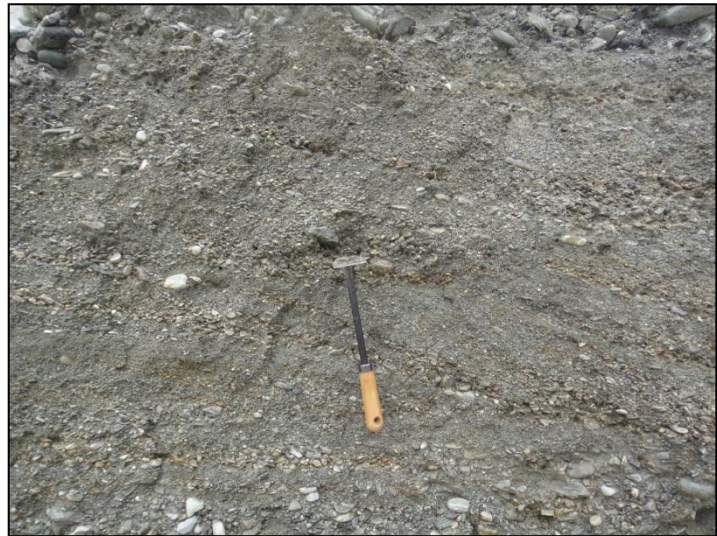
Figure 2.6 Lower Gravel Unit showing lenses of different sized gravels and sands.

i) Insitu description: Sandy, fine to coarse GRAVEL with cobbles and minor boulders and clay, dark grey, bedded. Loose, moist, well graded, fluvial structures, non plastic, Angular to sub rounded Gneiss and slightly weathered Schist gravel with rare Greywacke clasts, fine to coarse sand, Minor fraction.

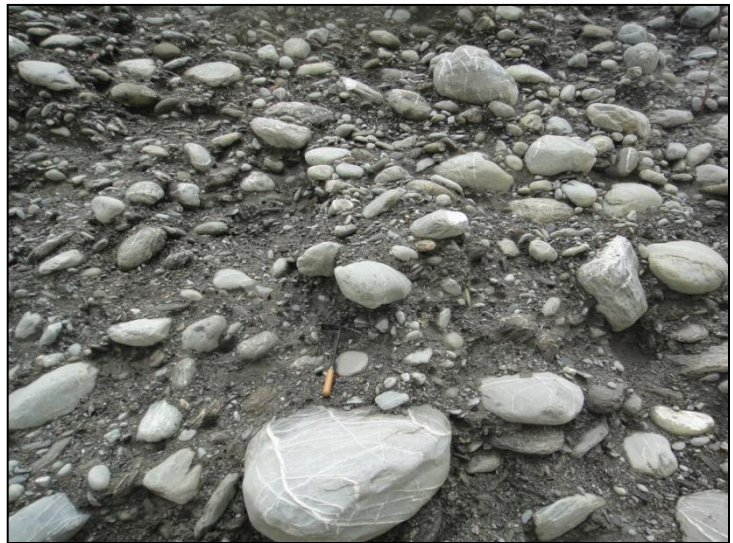
Figure 2.7 1620 & 1717 Gravel Unit illustrating the large boulders present and the upwards fining of the unit.

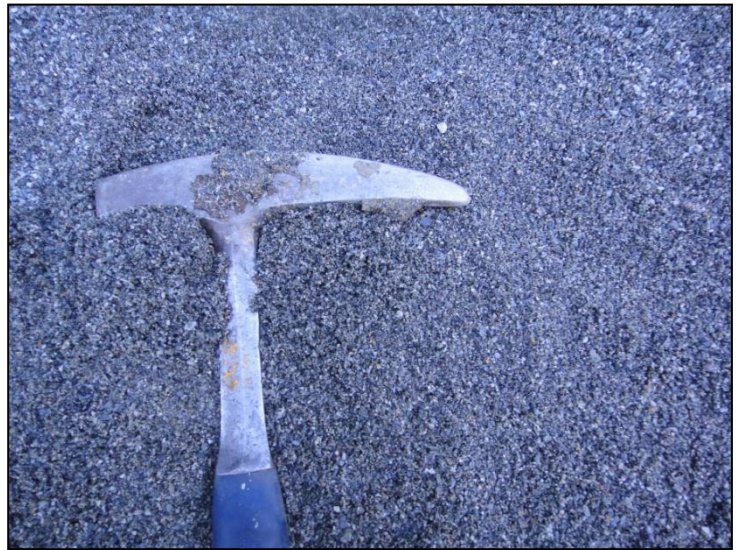
Figure 2.8 Coarse Sand – very uniform coarse sand.

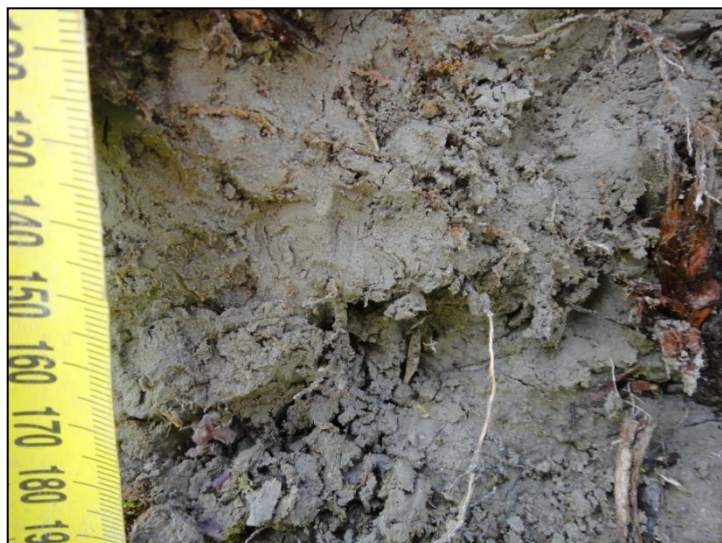
Figure 2.9 Clayey silt – present atop the 1620 surface.

e) Insitu description: SILT, trace of clay, dark brownish grey, soft, moist, very slightly plastic.

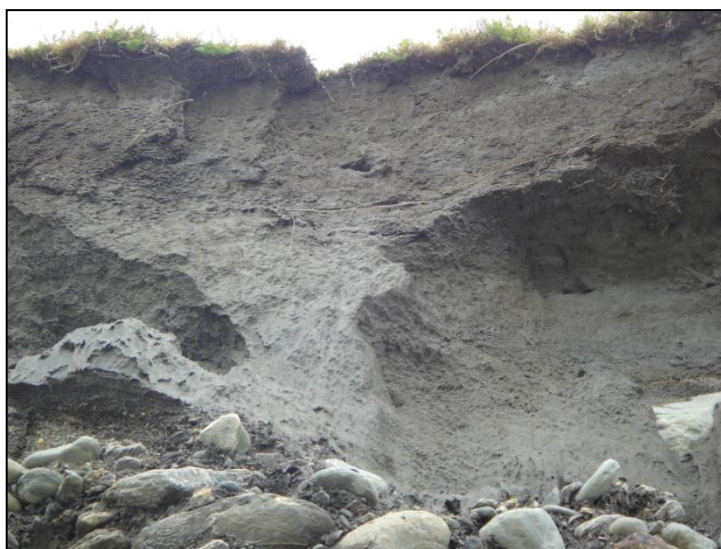
Figure 2.10 Sandy Silt - present atop the 1717 AD surface.

e) Insitu description: SILT, trace of fine sand, dark grey, soft, moist, non plastic.

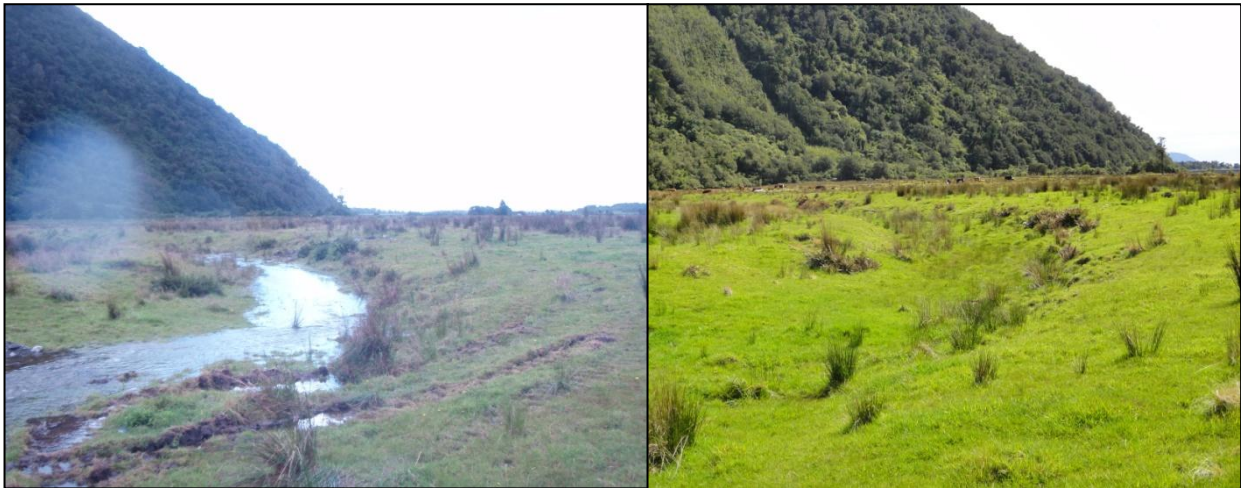
Figure 3.2 An example of one of the ephemeral channels in both Wet and Dry Conditions. Highlighting how easily areas of the terrace can become inundated.

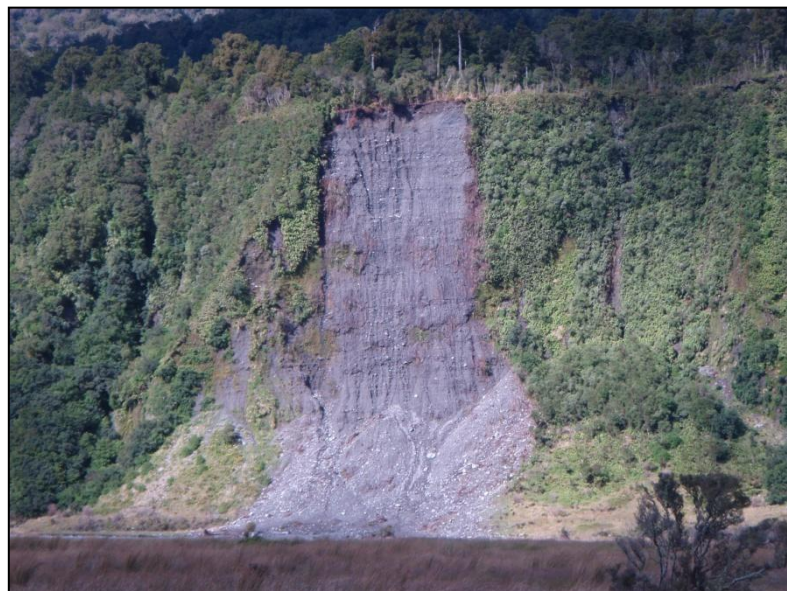
Figure 3.10 100m high gravel terrace on the east side of the river valley entirely made of gravels.

The 100m high, 10000 year old (McSaveney, 2002) terraces to the east are completely composed of gravels. There a number of streams and tributaries running off these cliffs depositing material into the river, there is also ongoing rock fall, like the example shown in Figure 3.10, also acting as a sediment supply.

The ~100m high gravel cliffs on the East side of the valley (Figure 3.10), do not pose a direct threat to the site, however if they were to catastrophically fail they could cause the Whataroa river to avulse, thereby increasing erosion rates at the cutbank towards the drill site, or cause avulsion onto the work area. There is no evidence of this happening in the past.

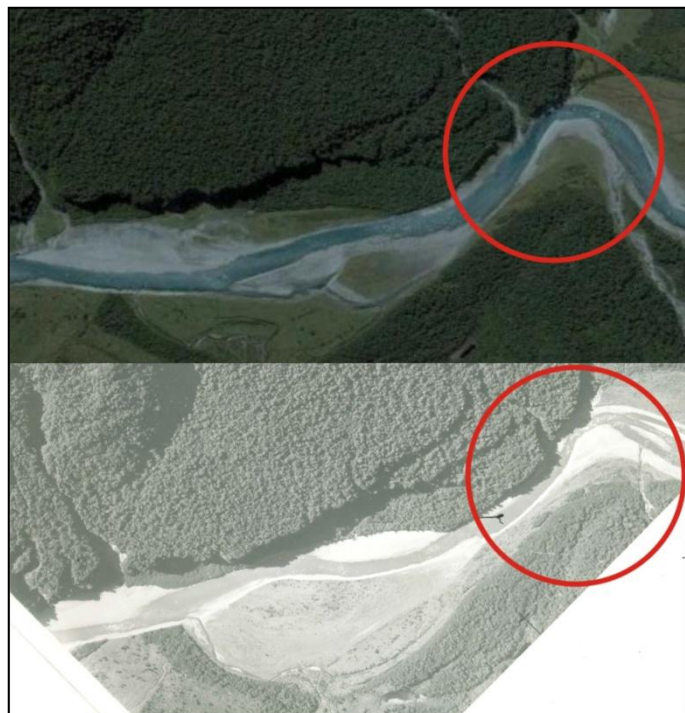
Figure 3.11 Comparison between 1948 and 2002 directly upstream of the erosion area showing relatively unchanged river dynamics. This could suggest it is something downstream of this point that is causing the increased erosion.

The volume of the small scallop in the West terrace is equivalent to about 35% of the volume of sediment removed from the East terrace (Figure 3.12). The relatively sudden input of this sediment could have triggered the river to start migrating eastward to where it is now. The fact that the water “outlet” directly up stream has barely changed (Figure 3.11) since 1948 supports this, as the flow has been coming from the same direction the entire time.

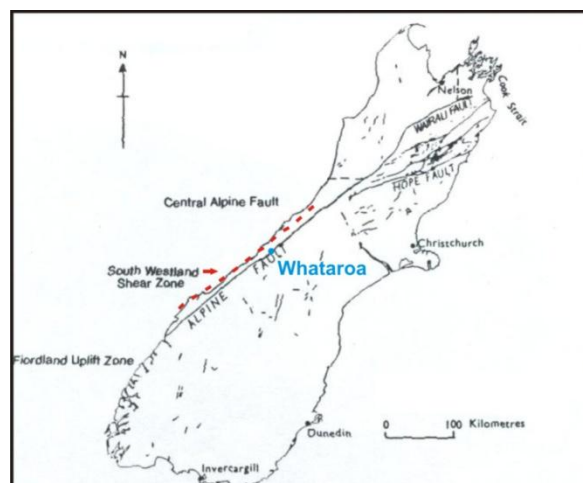
Figure 3.20 Approximate location of the South Westland Fault and Shear Zone. Modified from Benn (1992) with data from Cox & Barrell (2007) and Rattenbury, Jongens, & Cox (2010)

The South Westland Fault zone is a proposed distinct zone of shear faulting in Tertiary rocks that trend parallel to the Alpine Fault and is mapped onshore approximately 10 km from the site at Whataroa (Cox & Barrell, 2007) (Figure 3.20). It is characterised by closely spaced faults, separating steeply dipping slices of

Tertiary rocks (Benn, 1992). Quaternary deposits have buried large areas of this fault zone and it is proposed that more research required to establish the exact nature and history of faulting.

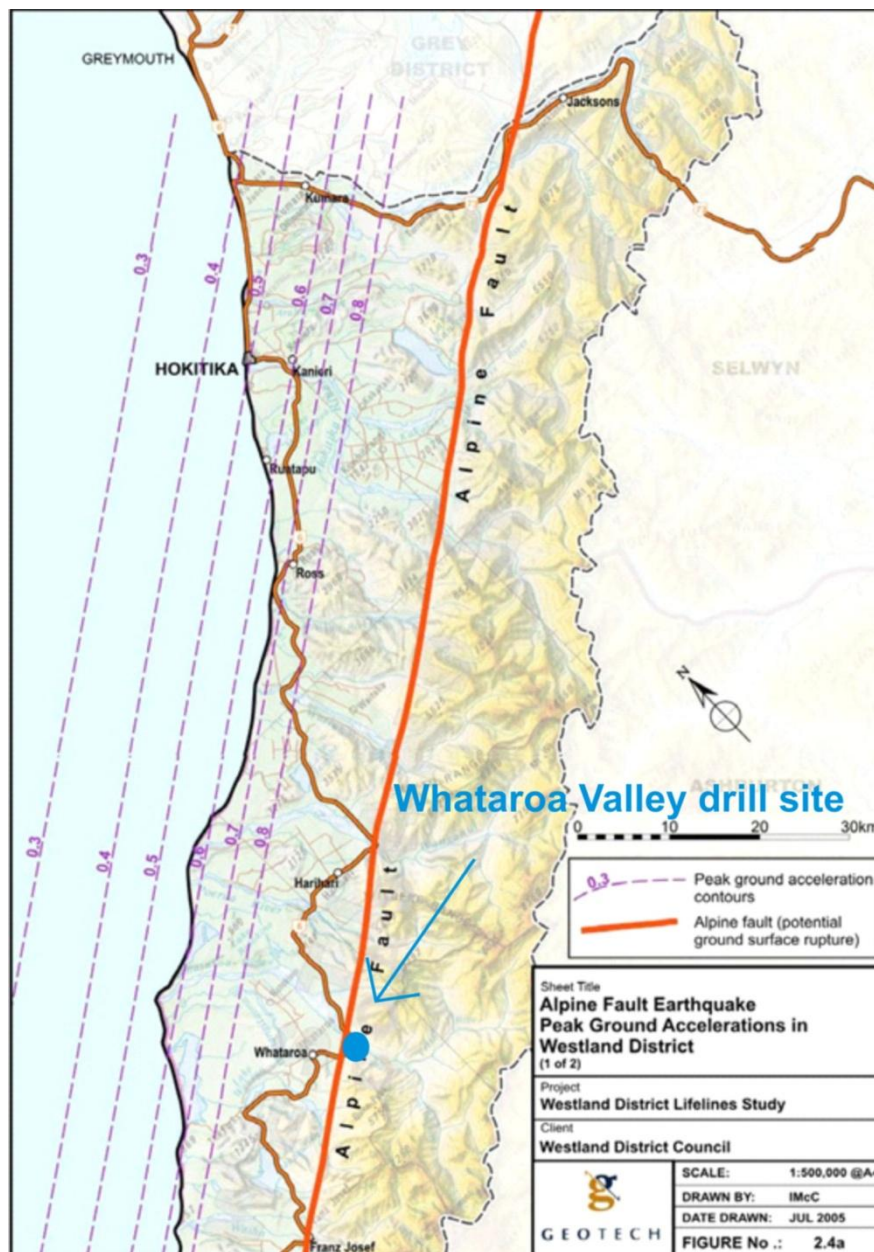
Figure 3.22 Alpine Fault earthquake peak ground accelerations for deep soils in Westland District (Westland District Council, 2006). The Whataroa drill site is illustrated here for reference to its location over the fault line.

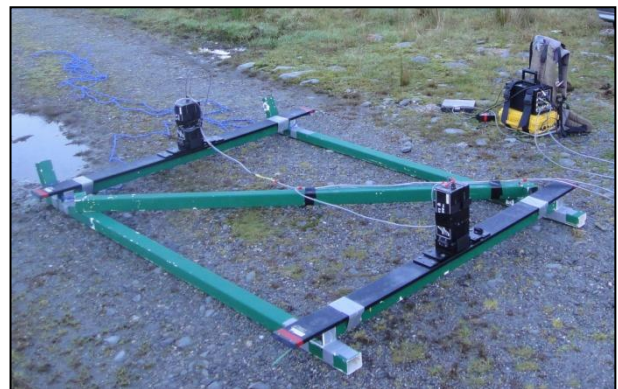
Figure 5.4 GPR Setup of the 50MHz GPR antennas

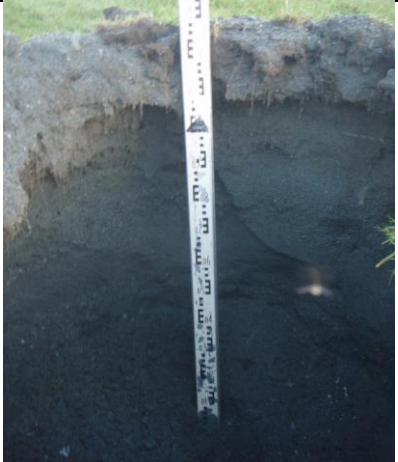
FROM (m): <u>0</u>		TO (m): <u>1.3</u>		Photo

TERTIARY COMPONENT		SECONDARY COMPONENT		
		Gravelly		
PRIMARY COMPONENT		Sand		
MODIFIER	MINOR COMPONENT		PLASTICITY	
with	Cobbles & Boulders		Non	
PARTICLE SIZE		MODIFIER	PARTICLE SIZE	
Medium sand		to	Coarse sand	
PARTICLE SHAPE		MODIFIER	PARTICLE SHAPE	
Subrounded		to	angular	
COLOUR 1		COLOUR 2		MOISTURE
Grey				Moist
CONSISTENCY / DENSITY		MODIFIER	CONSISTENCY / DENSITY	
Loose				
ADDITIONAL COMMENTS				
Rootlets down to 200mm				
Boulders up to 400mm in size

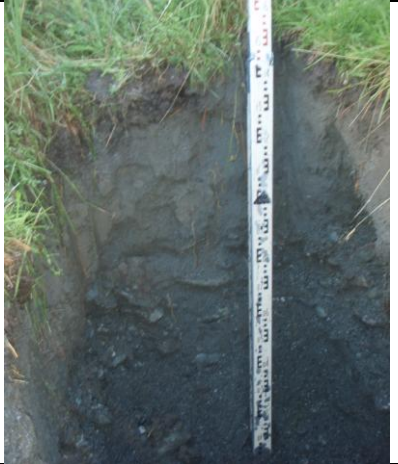
FROM (m): <u>0</u> TO (m): <u>0.7</u>				Photo

<small>TERTIARY COMPONENT</small>		<small>SECONDARY COMPONENT</small>			<small>PRIMARY COMPONENT</small>
					Sand
<small>MODIFIER</small>	<small>MINOR COMPONENT</small>				<small>PLASTICITY</small>
					Non
<small>PARTICLE SIZE</small>		<small>MODIFIER</small>	<small>PARTICLE SIZE</small>		
Medium sand		to	Coarse sand		
<small>PARTICLE SHAPE</small>		<small>MODIFIER</small>	<small>PARTICLE SHAPE</small>		
Subrounded		to	angular		
<small>COLOUR 1</small>		<small>COLOUR 2</small>			<small>MOISTURE</small>
Grey				Moist	
<small>CONSISTENCY / DENSITY</small>		<small>MODIFIER</small>	<small>CONSISTENCY / DENSITY</small>		
Loose					
<small>ADDITIONAL COMMENTS</small>					
Rootlets down to 500mm,					
Topsoil grading to sand within 100mm

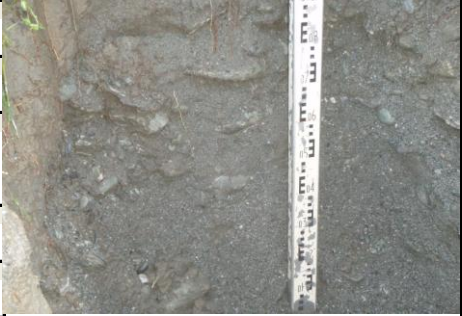
FROM (m): <u>0.7</u> TO (m): <u>1.6</u>				Photo

<small>TERTIARY COMPONENT</small>		<small>SECONDARY COMPONENT</small>			<small>PRIMARY COMPONENT</small>
		Sandy			Gravel
<small>MODIFIER</small>	<small>MINOR COMPONENT</small>				<small>PLASTICITY</small>
With	Cobbles & Boulders				non
<small>PARTICLE SIZE</small>		<small>MODIFIER</small>	<small>PARTICLE SIZE</small>		
Medium Sand		to	Coarse Sand		
Fine Gravel		to	Coarse Gravel		
<small>PARTICLE SHAPE</small>		<small>MODIFIER</small>	<small>PARTICLE SHAPE</small>		
Subrounded		to	Augular		
<small>COLOUR 1</small>		<small>COLOUR 2</small>		<small>MOISTURE</small>	
Grey				Moist	
<small>CONSISTENCY / DENSITY</small>		<small>MODIFIER</small>	<small>CONSISTENCY / DENSITY</small>		
loose					
<small>ADDITIONAL COMMENTS</small>					
Boulders up to 500mm in size

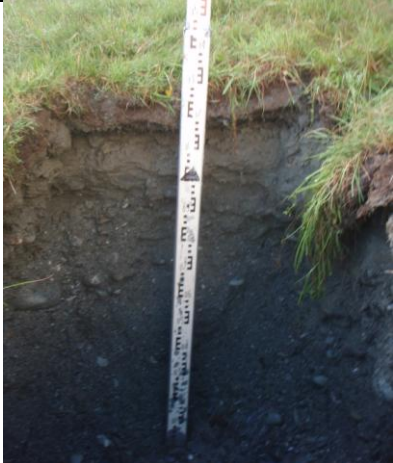
FROM (m): <u>0</u> TO (m): <u>0.5</u>				Photo

TERTIARY COMPONENT		SECONDARY COMPONENT			PRIMARY COMPONENT
					Sand
MODIFIER	MINOR COMPONENT				PLASTICITY
					Non
PARTICLE SIZE		MODIFIER	PARTICLE SIZE		
Fine sand		to	Medium sand		
PARTICLE SHAPE		MODIFIER	PARTICLE SHAPE		
Subrounded		to	angular		
COLOUR 1	COLOUR 2				MOISTURE
Grey				Moist	
CONSISTENCY / DENSITY			MODIFIER	CONSISTENCY / DENSITY	
Loose					
ADDITIONAL COMMENTS					
Rootlets down to 200mm,					
Topsoil grading to sand within 100mm

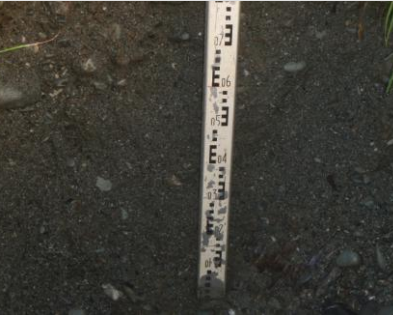
FROM (m): <u>0.5</u> TO (m): <u>1.3</u>				Photo

TERTIARY COMPONENT		SECONDARY COMPONENT			PRIMARY COMPONENT
		Sandy			Gravel
MODIFIER	MINOR COMPONENT				PLASTICITY
With	Cobbles & Boulders				non
PARTICLE SIZE		MODIFIER	PARTICLE SIZE		
Medium Sand		to	Coarse Sand		
Fine Gravel		to	Coarse Gravel		
PARTICLE SHAPE		MODIFIER	PARTICLE SHAPE		
Subrounded		to	Augular		
COLOUR 1	COLOUR 2			MOISTURE	
Grey				Moist	
CONSISTENCY / DENSITY			MODIFIER	CONSISTENCY / DENSITY	
loose					
ADDITIONAL COMMENTS

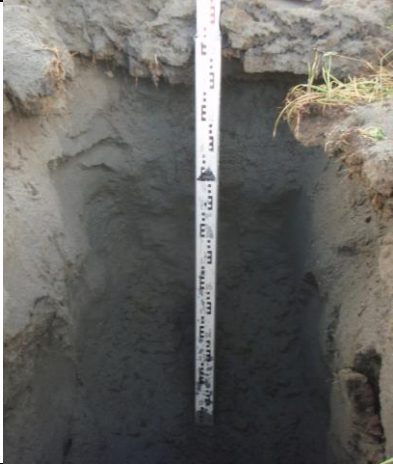
FROM (m): 0 TO (m): 1.5			Photo

<small>TERTIARY COMPONENT</small>		<small>SECONDARY COMPONENT</small>		<small>PRIMARY COMPONENT</small> Sand
<small>MODIFIER</small> trace	<small>MINOR COMPONENT</small> cobbles & boulders			<small>PLASTICITY</small> Non
<small>PARTICLE SIZE</small> Fine sand		<small>MODIFIER</small> to		<small>PARTICLE SIZE</small> coarse sand
<small>PARTICLE SHAPE</small> Subrounded		<small>MODIFIER</small> to		<small>PARTICLE SHAPE</small> angular
<small>COLOUR 1</small> Grey		<small>MOISTURE</small> Moist		
<small>CONSISTENCY / DENSITY</small> Loose		<small>CONSISTENCY / DENSITY</small>		
<small>ADDITIONAL COMMENTS</small> Rootlets down to 200mm, boulders up to 200mm in size

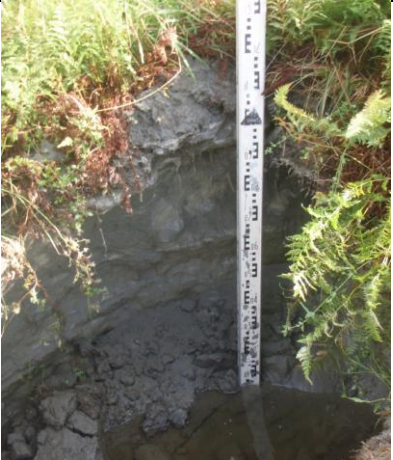
FROM (m): <u>0</u> TO (m): <u>1.3</u>			Photo

TERTIARY COMPONENT		SECONDARY COMPONENT		PRIMARY COMPONENT
				Sand
MODIFIER	MINOR COMPONENT			PLASTICITY
trace	boulders, cobbles & gravel			Non
PARTICLE SIZE		MODIFIER		PARTICLE SIZE
Fine sand		to		coarse sand
PARTICLE SHAPE		MODIFIER		PARTICLE SHAPE
Subrounded		to		angular
COLOUR 1	COLOUR 2			MOISTURE
Grey			Moist	
CONSISTENCY / DENSITY		MODIFIER	CONSISTENCY / DENSITY	
Loose				
ADDITIONAL COMMENTS				
water table at 1.2m depth? The hole was dug the previous day and it rained over night

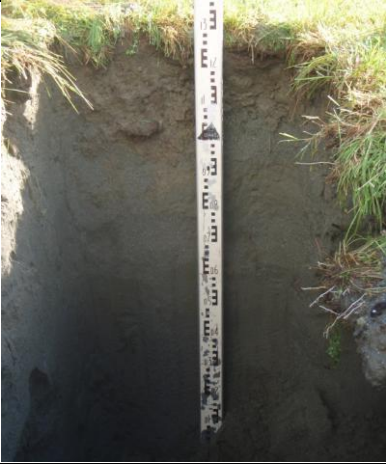
FROM (m): <u>0</u> TO (m): <u>1.3</u>				Photo

TERTIARY COMPONENT		SECONDARY COMPONENT			PRIMARY COMPONENT
					Sand
MODIFIER	MINOR COMPONENT		PLASTICITY		
trace	boulders, cobbles		Non		
PARTICLE SIZE		MODIFIER	PARTICLE SIZE		
Medium sand		to	coarse sand		
PARTICLE SHAPE		MODIFIER	PARTICLE SHAPE		
Subrounded		to	sub angular		
COLOUR 1	COLOUR 2		MOISTURE		
Grey			Moist		
CONSISTENCY / DENSITY		MODIFIER	CONSISTENCY / DENSITY		
Loose					
ADDITIONAL COMMENTS					
cobbles up to 50mm in size,					
topsoil grade to sand within 100mm

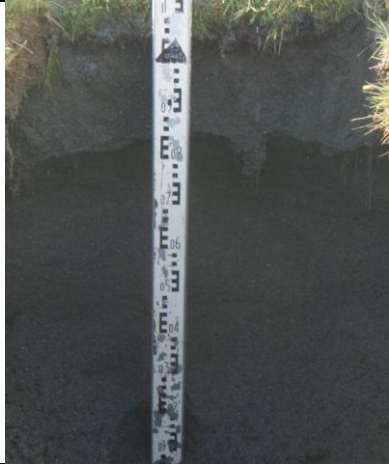
FROM (m): <u>0</u> TO (m): <u>1.1</u>			Photo

<small>TERTIARY COMPONENT</small>		<small>SECONDARY COMPONENT</small>		<small>PRIMARY COMPONENT</small> Coarse Sand
<small>MODIFIER</small> trace	<small>MINOR COMPONENT</small> Gravel & cobbles			<small>PLASTICITY</small> Non
<small>PARTICLE SIZE</small> coarse sand		<small>MODIFIER</small>		<small>PARTICLE SIZE</small>
<small>PARTICLE SHAPE</small> Subrounded		<small>MODIFIER</small> to		<small>PARTICLE SHAPE</small> angular
<small>COLOUR 1</small> Grey	<small>COLOUR 2</small>			<small>MOISTURE</small> Moist
<small>CONSISTENCY / DENSITY</small> Loose		<small>MODIFIER</small>		<small>CONSISTENCY / DENSITY</small>
<small>ADDITIONAL COMMENTS</small> cobbles up to 50mm in size,

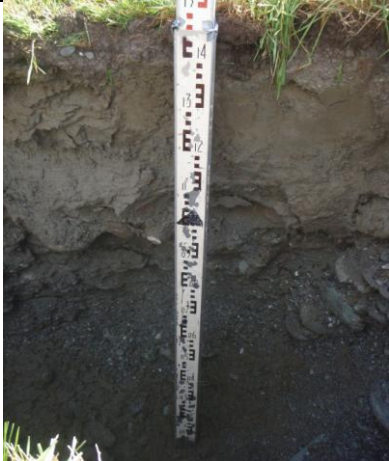
FROM (m): <u>0</u> TO (m): <u>0.6</u>				Photo

<small>TERTIARY COMPONENT</small>		<small>SECONDARY COMPONENT</small>			<small>PRIMARY COMPONENT</small>
		Silty			Sand
<small>MODIFIER</small>	<small>MINOR COMPONENT</small>				<small>PLASTICITY</small>
		Non			
<small>PARTICLE SIZE</small>		<small>MODIFIER</small>	<small>PARTICLE SIZE</small>		
Fine Sand					
<small>PARTICLE SHAPE</small>		<small>MODIFIER</small>	<small>PARTICLE SHAPE</small>		
Sub angular					
<small>COLOUR 1</small>		<small>COLOUR 2</small>			<small>MOISTURE</small>
brownish		grey		Moist	
<small>CONSISTENCY / DENSITY</small>		<small>MODIFIER</small>	<small>CONSISTENCY / DENSITY</small>		
Loose					
<small>ADDITIONAL COMMENTS</small>					
rootlets to 500mm

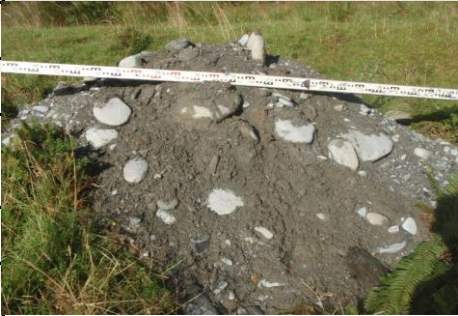
FROM (m): <u>0.6</u> TO (m): <u>1.5</u>				Photo

<small>TERTIARY COMPONENT</small>		<small>SECONDARY COMPONENT</small>			<small>PRIMARY COMPONENT</small>
Sandy		Bouldery			Gravel
<small>MODIFIER</small>	<small>MINOR COMPONENT</small>				<small>PLASTICITY</small>
		non			
<small>PARTICLE SIZE</small>		<small>MODIFIER</small>	<small>PARTICLE SIZE</small>		
Medium sand		to	Coarse sand		
Fine gravel		to	Coarse Gravel		
<small>PARTICLE SHAPE</small>		<small>MODIFIER</small>	<small>PARTICLE SHAPE</small>		
Sub rounded		to	Sub angular		
<small>COLOUR 1</small>		<small>COLOUR 2</small>		<small>MOISTURE</small>	
grey				moist	
<small>CONSISTENCY / DENSITY</small>		<small>MODIFIER</small>	<small>CONSISTENCY / DENSITY</small>		
loose					
<small>ADDITIONAL COMMENTS</small>					
Boulders to 400mm in size

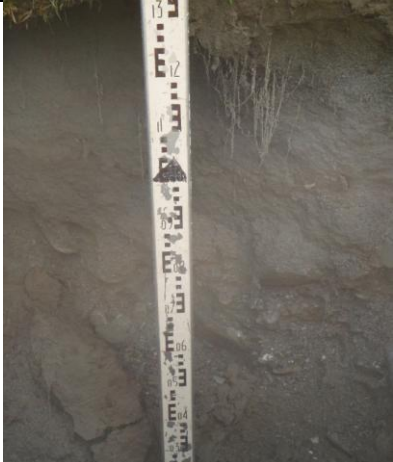
FROM (m): <u>0</u> TO (m): <u>0.7</u>			Photo

TERTIARY COMPONENT		SECONDARY COMPONENT		PRIMARY COMPONENT
				Sand
MODIFIER	MINOR COMPONENT			PLASTICITY
				Non
PARTICLE SIZE		MODIFIER		PARTICLE SIZE
Medium Sand				
PARTICLE SHAPE		MODIFIER		PARTICLE SHAPE
Sub angular		to		Sub rounded
COLOUR 1	COLOUR 2	MOISTURE		
grey		Moist		
CONSISTENCY / DENSITY		MODIFIER	CONSISTENCY / DENSITY	
Loose				
ADDITIONAL COMMENTS

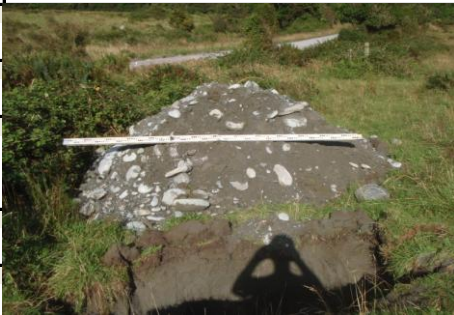
FROM (m): <u>0.7</u> TO (m): <u>1.5</u>			Photo

TERTIARY COMPONENT		SECONDARY COMPONENT		PRIMARY COMPONENT
Sandy		Bouldery		Gravel
MODIFIER	MINOR COMPONENT			PLASTICITY
				non
PARTICLE SIZE		MODIFIER		PARTICLE SIZE
Medium sand		to		Coarse sand
Fine gravel		to		Coarse Gravel
PARTICLE SHAPE		MODIFIER		PARTICLE SHAPE
Sub rounded		to		Sub angular
COLOUR 1	COLOUR 2	MOISTURE		
grey		moist		
CONSISTENCY / DENSITY		MODIFIER	CONSISTENCY / DENSITY	
loose				
ADDITIONAL COMMENTS				
Boulders to 400mm in size

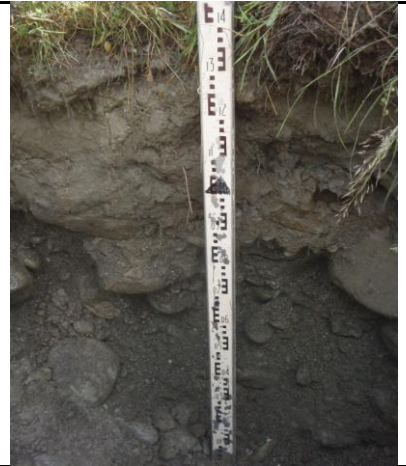
FROM (m): <u>0</u> TO (m): <u>0.5</u>				Photo	
TERTIARY COMPONENT		SECONDARY COMPONENT		PRIMARY COMPONENT	
				Sand	
MODIFIER	MINOR COMPONENT			PLASTICITY	
				Non	
PARTICLE SIZE		MODIFIER		PARTICLE SIZE	
Medium Sand					
PARTICLE SHAPE		MODIFIER		PARTICLE SHAPE	
Sub angular		to		Sub rounded	
COLOUR 1	COLOUR 2			MOISTURE	
grey				Moist	
CONSISTENCY / DENSITY		MODIFIER		CONSISTENCY / DENSITY	
Loose					
ADDITIONAL COMMENTS					
Rootlets down to 600mm

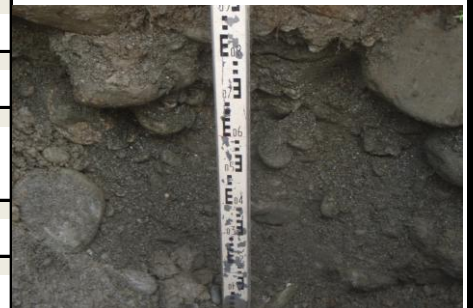
FROM (m): <u>0.5</u> TO (m): <u>1.5</u>				Photo	
TERTIARY COMPONENT		SECONDARY COMPONENT		PRIMARY COMPONENT	
Sandy		Bouldery		Gravel	
MODIFIER	MINOR COMPONENT			PLASTICITY	
				non	
PARTICLE SIZE		MODIFIER		PARTICLE SIZE	
Medium sand		to		Coarse sand	
Fine gravel		to		Coarse Gravel	
PARTICLE SHAPE		MODIFIER		PARTICLE SHAPE	
Sub rounded		to		Sub angular	
COLOUR 1	COLOUR 2			MOISTURE	
grey				moist	
CONSISTENCY / DENSITY		MODIFIER		CONSISTENCY / DENSITY	
loose					
ADDITIONAL COMMENTS					
Boulders to 600mm in size

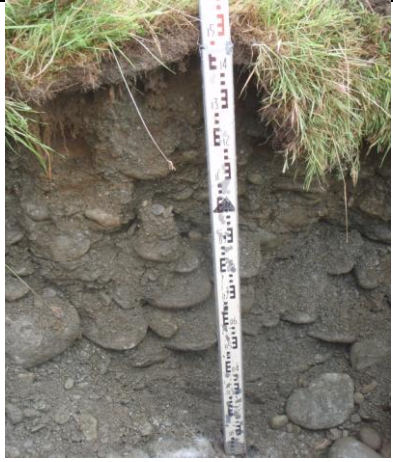
FROM (m): <u>0.1</u> TO (m): <u>1.6</u>				Photo

<small>TERTIARY COMPONENT</small> Sandy		<small>SECONDARY COMPONENT</small> Bouldery			<small>PRIMARY COMPONENT</small> Gravel
<small>MODIFIER</small>	<small>MINOR COMPONENT</small>				<small>PLASTICITY</small> non
<small>PARTICLE SIZE</small> Medium sand Fine gravel		<small>MODIFIER</small> to to	<small>PARTICLE SIZE</small> Coarse sand Coarse Gravel		
<small>PARTICLE SHAPE</small> Sub rounded		<small>MODIFIER</small> to	<small>PARTICLE SHAPE</small> Sub angular		
<small>COLOUR 1</small> grey		<small>COLOUR 2</small>			<small>MOISTURE</small> moist
<small>CONSISTENCY / DENSITY</small> loose		<small>MODIFIER</small>	<small>CONSISTENCY / DENSITY</small>		
<small>ADDITIONAL COMMENTS</small> Boulders to 700mm in size

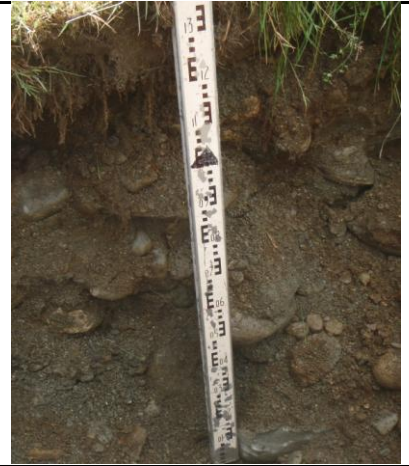
FROM (m): <u>0.2</u> TO (m): <u>1.4</u>				Photo	
TERTIARY COMPONENT Sandy		SECONDARY COMPONENT Bouldery		PRIMARY COMPONENT Gravel	
MODIFIER	MINOR COMPONENT			PLASTICITY non	
PARTICLE SIZE Medium sand Fine gravel		MODIFIER to to	PARTICLE SIZE Coarse sand Coarse Gravel		
PARTICLE SHAPE Sub rounded		MODIFIER to	PARTICLE SHAPE Sub angular		
COLOUR 1 grey		COLOUR 2		MOISTURE moist	
CONSISTENCY / DENSITY loose		MODIFIER		CONSISTENCY / DENSITY	
ADDITIONAL COMMENTS Boulders to 700mm in size Rootlets down to 300mm

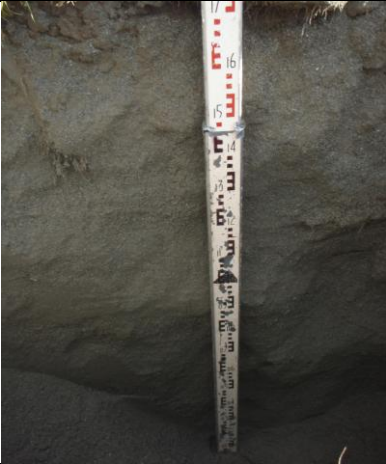
FROM (m): <u>0</u> TO (m): <u>1.8</u>			Photo

<small>TERTIARY COMPONENT</small>		<small>SECONDARY COMPONENT</small>		<small>PRIMARY COMPONENT</small> Coarse Sand
<small>MODIFIER</small> Trace	<small>MINOR COMPONENT</small> Boulders & Cobbles			<small>PLASTICITY</small> non
<small>PARTICLE SIZE</small> Medium sand		<small>MODIFIER</small> to		<small>PARTICLE SIZE</small> Coarse sand
<small>PARTICLE SHAPE</small> Sub rounded		<small>MODIFIER</small> to		<small>PARTICLE SHAPE</small> Sub angular
<small>COLOUR 1</small> grey	<small>COLOUR 2</small>			<small>MOISTURE</small> moist
<small>CONSISTENCY / DENSITY</small> loose		<small>MODIFIER</small>		<small>CONSISTENCY / DENSITY</small>
<small>ADDITIONAL COMMENTS</small> Only one boulder - 600mm

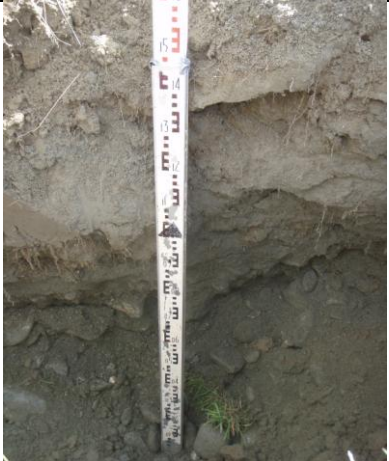
FROM (m): <u>0</u> TO (m): <u>0.7</u>				Photo

<small>TERTIARY COMPONENT</small>		<small>SECONDARY COMPONENT</small>			<small>PRIMARY COMPONENT</small>
					Sand
<small>MODIFIER</small>	<small>MINOR COMPONENT</small>				<small>PLASTICITY</small>
					non
<small>PARTICLE SIZE</small>		<small>MODIFIER</small>	<small>PARTICLE SIZE</small>		
Medium sand		to	Coarse sand		
<small>PARTICLE SHAPE</small>		<small>MODIFIER</small>	<small>PARTICLE SHAPE</small>		
Sub rounded		to	Sub angular		
<small>COLOUR 1</small>		<small>COLOUR 2</small>			<small>MOISTURE</small>
grey				moist	
<small>CONSISTENCY / DENSITY</small>			<small>MODIFIER</small>	<small>CONSISTENCY / DENSITY</small>	
loose					
<small>ADDITIONAL COMMENTS</small>					
Rootlets to 700mm

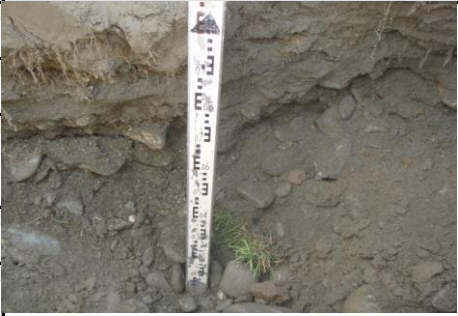
FROM (m): <u>0.7</u> TO (m): <u>1.6</u>				Photo

<small>TERTIARY COMPONENT</small>		<small>SECONDARY COMPONENT</small>			<small>PRIMARY COMPONENT</small>
		Sandy			Gravel
<small>MODIFIER</small>	<small>MINOR COMPONENT</small>				<small>PLASTICITY</small>
with	Boulders & cobbles				non
<small>PARTICLE SIZE</small>		<small>MODIFIER</small>	<small>PARTICLE SIZE</small>		
Fine sand		to	Coarse sand		
Fine gravel		to	Coarse gravel		
<small>PARTICLE SHAPE</small>		<small>MODIFIER</small>	<small>PARTICLE SHAPE</small>		
Sub angular		to	Sub rounded		
<small>COLOUR 1</small>		<small>COLOUR 2</small>		<small>MOISTURE</small>	
grey				Moist	
<small>CONSISTENCY / DENSITY</small>			<small>MODIFIER</small>	<small>CONSISTENCY / DENSITY</small>	
loose					
<small>ADDITIONAL COMMENTS</small>					
Boulders up to 300mm in size.

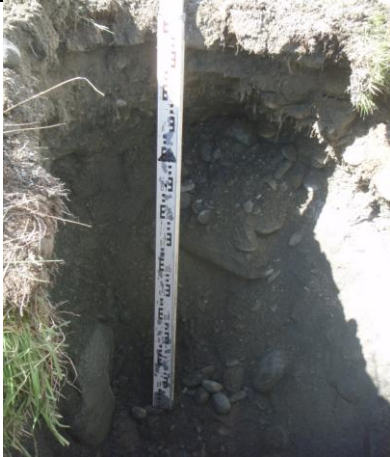
FROM (m): <u>0</u> TO (m): <u>0.4</u>				Photo

<small>TERTIARY COMPONENT</small>		<small>SECONDARY COMPONENT</small>			<small>PRIMARY COMPONENT</small>
					Sand
<small>MODIFIER</small>	<small>MINOR COMPONENT</small>				<small>PLASTICITY</small>
					non
<small>PARTICLE SIZE</small>		<small>MODIFIER</small>	<small>PARTICLE SIZE</small>		
Medium sand					
<small>PARTICLE SHAPE</small>		<small>MODIFIER</small>	<small>PARTICLE SHAPE</small>		
Sub rounded		to	Sub angular		
<small>COLOUR 1</small>	<small>COLOUR 2</small>		<small>MOISTURE</small>		
grey			moist		
<small>CONSISTENCY / DENSITY</small>		<small>MODIFIER</small>	<small>CONSISTENCY / DENSITY</small>		
loose					
<small>ADDITIONAL COMMENTS</small>					
Rootlets to 700mm

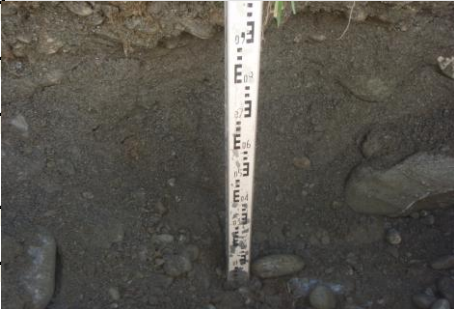
FROM (m): <u>0.4</u> TO (m): <u>1.5</u>				Photo

<small>TERTIARY COMPONENT</small>		<small>SECONDARY COMPONENT</small>			<small>PRIMARY COMPONENT</small>
		Sandy			Gravel
<small>MODIFIER</small>	<small>MINOR COMPONENT</small>				<small>PLASTICITY</small>
with	Boulders & cobbles				non
<small>PARTICLE SIZE</small>		<small>MODIFIER</small>	<small>PARTICLE SIZE</small>		
Med sand		to	Coarse sand		
Fine gravel		to	Coarse gravel		
<small>PARTICLE SHAPE</small>		<small>MODIFIER</small>	<small>PARTICLE SHAPE</small>		
Sub angular		to	Sub rounded		
<small>COLOUR 1</small>	<small>COLOUR 2</small>		<small>MOISTURE</small>		
grey			Moist		
<small>CONSISTENCY / DENSITY</small>		<small>MODIFIER</small>	<small>CONSISTENCY / DENSITY</small>		
loose					
<small>ADDITIONAL COMMENTS</small>					
Boulders up to 600mm in size.

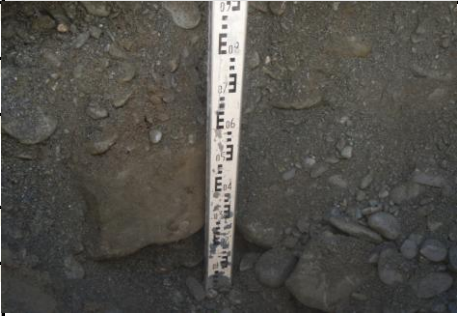
FROM (m): <u>0.5</u> TO (m): <u>1.6</u>				Photo

<small>TERTIARY COMPONENT</small>		<small>SECONDARY COMPONENT</small>			<small>PRIMARY COMPONENT</small>
		Sandy			Gravel
<small>MODIFIER</small>	<small>MINOR COMPONENT</small>				<small>PLASTICITY</small>
with	Boulders & cobbles				non
<small>PARTICLE SIZE</small>		<small>MODIFIER</small>	<small>PARTICLE SIZE</small>		
Med sand		to	Coarse sand		
Fine gravel		to	Coarse gravel		
<small>PARTICLE SHAPE</small>		<small>MODIFIER</small>	<small>PARTICLE SHAPE</small>		
Sub angular		to	Sub rounded		
<small>COLOUR 1</small>	<small>COLOUR 2</small>			<small>MOISTURE</small>	
grey				Moist	
<small>CONSISTENCY / DENSITY</small>		<small>MODIFIER</small>	<small>CONSISTENCY / DENSITY</small>		
loose					
<small>ADDITIONAL COMMENTS</small>					
Boulders up to 500mm in size.

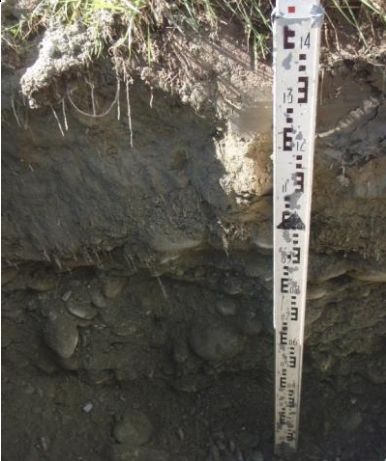
FROM (m): <u>0</u> TO (m): <u>0.5</u>				Photo

<small>TERTIARY COMPONENT</small>		<small>SECONDARY COMPONENT</small>			<small>PRIMARY COMPONENT</small>
					Sand
<small>MODIFIER</small>	<small>MINOR COMPONENT</small>				<small>PLASTICITY</small>
					non
<small>PARTICLE SIZE</small>		<small>MODIFIER</small>	<small>PARTICLE SIZE</small>		
Medium sand					
<small>PARTICLE SHAPE</small>		<small>MODIFIER</small>	<small>PARTICLE SHAPE</small>		
Sub rounded		to	Sub angular		
<small>COLOUR 1</small>	<small>COLOUR 2</small>		<small>MOISTURE</small>		
grey			moist		
<small>CONSISTENCY / DENSITY</small>		<small>MODIFIER</small>	<small>CONSISTENCY / DENSITY</small>		
loose					
<small>ADDITIONAL COMMENTS</small>					
Rootlets to 600mm

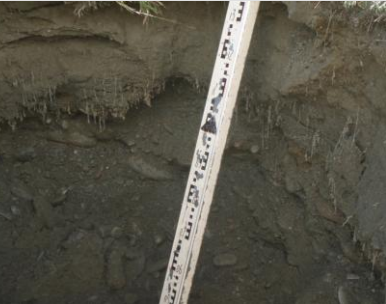
FROM (m): <u>0.5</u> TO (m): <u>1.5</u>				Photo

<small>TERTIARY COMPONENT</small>		<small>SECONDARY COMPONENT</small>			<small>PRIMARY COMPONENT</small>
		Sandy			Gravel
<small>MODIFIER</small>	<small>MINOR COMPONENT</small>				<small>PLASTICITY</small>
with	Boulders & cobbles				non
<small>PARTICLE SIZE</small>		<small>MODIFIER</small>	<small>PARTICLE SIZE</small>		
Med sand Fine gravel		to to	Coarse sand Coarse gravel		
<small>PARTICLE SHAPE</small>		<small>MODIFIER</small>	<small>PARTICLE SHAPE</small>		
Sub angular		to	Sub rounded		
<small>COLOUR 1</small>	<small>COLOUR 2</small>		<small>MOISTURE</small>		
grey			Moist		
<small>CONSISTENCY / DENSITY</small>		<small>MODIFIER</small>	<small>CONSISTENCY / DENSITY</small>		
loose					
<small>ADDITIONAL COMMENTS</small>					
Boulders up to 500mm in size.

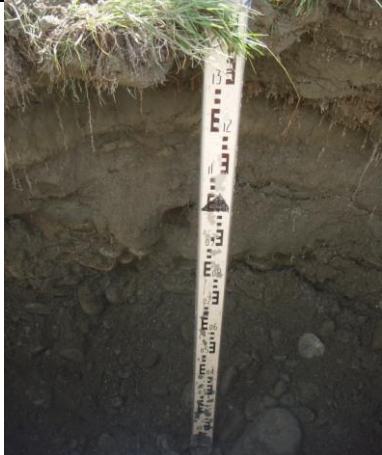
FROM (m): <u>0</u> TO (m): <u>0.7</u>				Photo

TERTIARY COMPONENT		SECONDARY COMPONENT			PRIMARY COMPONENT
					Sand
MODIFIER	MINOR COMPONENT				PLASTICITY
					non
PARTICLE SIZE		MODIFIER	PARTICLE SIZE		
Medium sand					
PARTICLE SHAPE		MODIFIER	PARTICLE SHAPE		
Sub rounded		to	Sub angular		
COLOUR 1	COLOUR 2		MOISTURE		
grey			moist		
CONSISTENCY / DENSITY		MODIFIER	CONSISTENCY / DENSITY		
loose					
ADDITIONAL COMMENTS					
Rootlets to 900mm

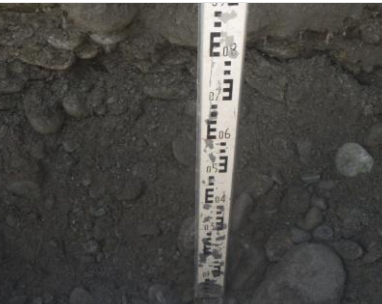
FROM (m): <u>0.7</u> TO (m): <u>1.6</u>				Photo

TERTIARY COMPONENT		SECONDARY COMPONENT			PRIMARY COMPONENT
		Sandy			Gravel
MODIFIER	MINOR COMPONENT				PLASTICITY
with	Boulders & cobbles				non
PARTICLE SIZE		MODIFIER	PARTICLE SIZE		
Med sand		to	Coarse sand		
Fine gravel		to	Coarse gravel		
PARTICLE SHAPE		MODIFIER	PARTICLE SHAPE		
Sub angular		to	Sub rounded		
COLOUR 1	COLOUR 2		MOISTURE		
grey			Moist		
CONSISTENCY / DENSITY		MODIFIER	CONSISTENCY / DENSITY		
loose					
ADDITIONAL COMMENTS					
Boulders up to 400mm in size.

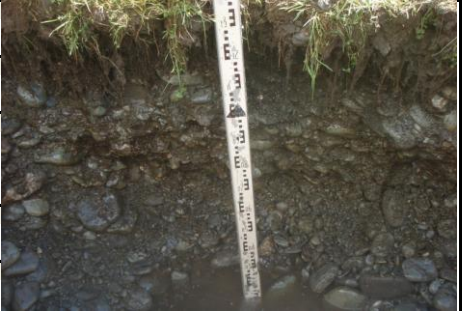
FROM (m): <u>0</u> TO (m): <u>0.7</u>			Photo

<small>TERTIARY COMPONENT</small> Sandy		<small>SECONDARY COMPONENT</small> Cobbley		<small>PRIMARY COMPONENT</small> Gravel
<small>MODIFIER</small> with	<small>MINOR COMPONENT</small> Boulders			<small>PLASTICITY</small> non
<small>PARTICLE SIZE</small> Medium sand Fine		<small>MODIFIER</small> to to		<small>PARTICLE SIZE</small> Coarse Sand Coarse Gravel
<small>PARTICLE SHAPE</small> Sub rounded		<small>MODIFIER</small> to		<small>PARTICLE SHAPE</small> Sub angular
<small>COLOUR 1</small> grey	<small>COLOUR 2</small>			<small>MOISTURE</small> wet
<small>CONSISTENCY / DENSITY</small> loose		<small>MODIFIER</small>		<small>CONSISTENCY / DENSITY</small>
<small>ADDITIONAL COMMENTS</small> Boulders to 700mm				
<small>ADDITIONAL COMMENTS</small> Swamp flowing into hole, water table at 1.3m?

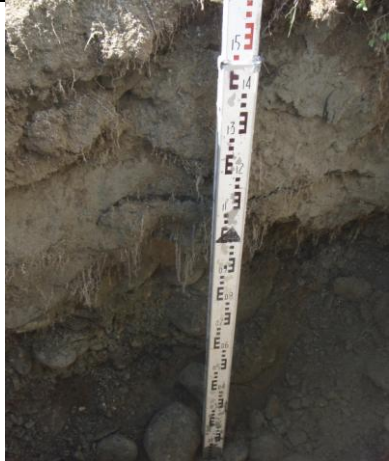
FROM (m): <u>0</u> TO (m): <u>0.7</u>				Photo

<small>TERTIARY COMPONENT</small>		<small>SECONDARY COMPONENT</small>			<small>PRIMARY COMPONENT</small>
					Sand
<small>MODIFIER</small>	<small>MINOR COMPONENT</small>				<small>PLASTICITY</small>
					non
<small>PARTICLE SIZE</small>		<small>MODIFIER</small>	<small>PARTICLE SIZE</small>		
Medium sand					
<small>PARTICLE SHAPE</small>		<small>MODIFIER</small>	<small>PARTICLE SHAPE</small>		
Sub rounded		to	Sub angular		
<small>COLOUR 1</small>	<small>COLOUR 2</small>		<small>MOISTURE</small>		
Brownish	Grey		moist		
<small>CONSISTENCY / DENSITY</small>		<small>MODIFIER</small>	<small>CONSISTENCY / DENSITY</small>		
loose					
<small>ADDITIONAL COMMENTS</small>					
Rootlets to 800mm

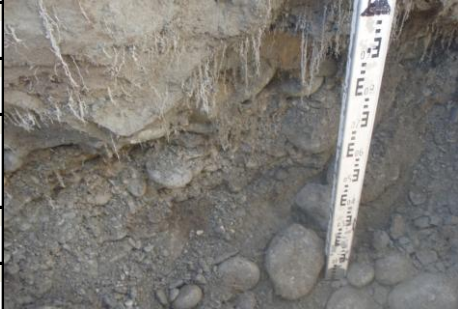
FROM (m): <u>0.7</u> TO (m): <u>1.6</u>				Photo

<small>TERTIARY COMPONENT</small>		<small>SECONDARY COMPONENT</small>			<small>PRIMARY COMPONENT</small>
		Sandy			Gravel
<small>MODIFIER</small>	<small>MINOR COMPONENT</small>				<small>PLASTICITY</small>
with	Boulders & cobbles				non
<small>PARTICLE SIZE</small>		<small>MODIFIER</small>	<small>PARTICLE SIZE</small>		
Med sand		to	Coarse sand		
Fine gravel		to	Coarse gravel		
<small>PARTICLE SHAPE</small>		<small>MODIFIER</small>	<small>PARTICLE SHAPE</small>		
Sub angular		to	Sub rounded		
<small>COLOUR 1</small>	<small>COLOUR 2</small>		<small>MOISTURE</small>		
grey			Moist		
<small>CONSISTENCY / DENSITY</small>		<small>MODIFIER</small>	<small>CONSISTENCY / DENSITY</small>		
loose					
<small>ADDITIONAL COMMENTS</small>					
Boulders up to 500mm in size.

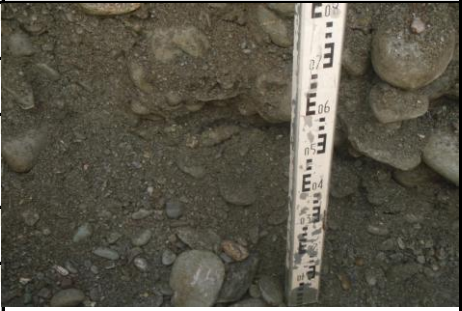
FROM (m): <u>0.2</u> TO (m): <u>1.4</u>				Photo

TERTIARY COMPONENT		SECONDARY COMPONENT			PRIMARY COMPONENT
		Sandy			Gravel
MODIFIER	MINOR COMPONENT				PLASTICITY
with	Boulders & cobbles				non
PARTICLE SIZE		MODIFIER	PARTICLE SIZE		
Med sand		to	Coarse sand		
Fine gravel		to	Coarse gravel		
PARTICLE SHAPE		MODIFIER	PARTICLE SHAPE		
Sub angular		to	Sub rounded		
COLOUR 1		COLOUR 2		MOISTURE	
grey				Moist	
CONSISTENCY / DENSITY		MODIFIER	CONSISTENCY / DENSITY		
loose					
ADDITIONAL COMMENTS					
Boulders up to 500mm in size.

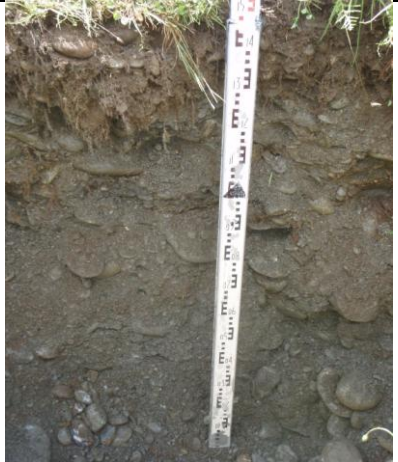
FROM (m): <u>0</u> TO (m): <u>1.6</u>				Photo

TERTIARY COMPONENT		SECONDARY COMPONENT			PRIMARY COMPONENT
		Sandy			Gravel
MODIFIER	MINOR COMPONENT		PLASTICITY		
with	Cobbles & Boulders		non		
PARTICLE SIZE		MODIFIER			PARTICLE SIZE
Med sand		to			Coarse sand
Fine gravel		to			Coarse gravel
PARTICLE SHAPE		MODIFIER			PARTICLE SHAPE
Sub-rounded		to			Sub-angular
COLOUR 1		COLOUR 2		MOISTURE	
Grey				moist	
CONSISTENCY / DENSITY		MODIFIER		CONSISTENCY / DENSITY	
loose					
ADDITIONAL COMMENTS					
Boulders up to 600mm in size					
Rootlets to 400mm

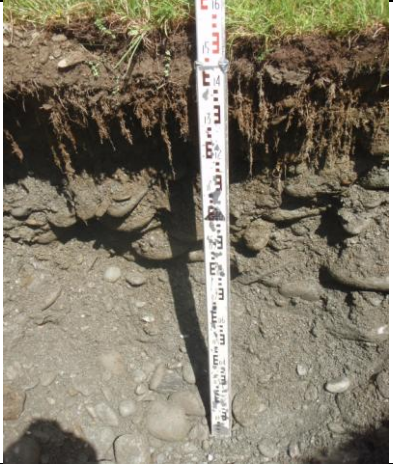
FROM (m): <u>0</u> TO (m): <u>1.6</u>				Photo

TERTIARY COMPONENT		SECONDARY COMPONENT			PRIMARY COMPONENT	
		<u>Sandy</u>			<u>Gravel</u>	
MODIFIER	MINOR COMPONENT				PLASTICITY	
<u>with</u>	<u>Cobbles & Boulders</u>				<u>non</u>	
PARTICLE SIZE		MODIFIER			PARTICLE SIZE	
<u>Med sand</u>		<u>to</u>			<u>Coarse sand</u>	
<u>Fine gravel</u>		<u>to</u>			<u>Coarse gravel</u>	
PARTICLE SHAPE		MODIFIER			PARTICLE SHAPE	
<u>Sub-rounded</u>		<u>to</u>			<u>Sub-angular</u>	
COLOUR 1		COLOUR 2		MOISTURE		
<u>Grey</u>				<u>moist</u>		
CONSISTENCY / DENSITY			MODIFIER		CONSISTENCY / DENSITY	
<u>loose</u>						
ADDITIONAL COMMENTS						
<u>Boulders up to 600mm in size</u>						
<u>Rootlets to 400mm</u>

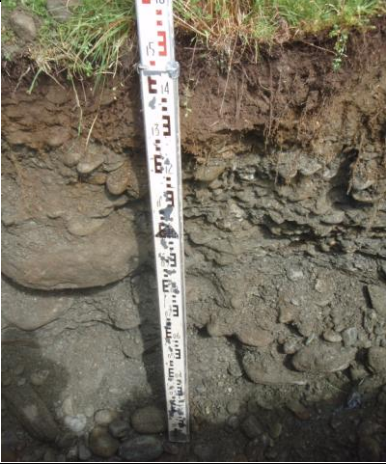
FROM (m): 0 TO (m): 1.5			Photo

TERTIARY COMPONENT		SECONDARY COMPONENT		PRIMARY COMPONENT
		Sandy		Gravel
MODIFIER	MINOR COMPONENT	PLASTICITY		
with	Cobbles & Boulders	non		
PARTICLE SIZE		MODIFIER		PARTICLE SIZE
Med sand		to		Coarse sand
Fine gravel		to		Coarse gravel
PARTICLE SHAPE		MODIFIER		PARTICLE SHAPE
Sub-rounded		to		Sub-angular
COLOUR 1	COLOUR 2		MOISTURE	
Grey			moist	
CONSISTENCY / DENSITY		MODIFIER	CONSISTENCY / DENSITY	
loose				
ADDITIONAL COMMENTS				
Boulders up to 600mm in size				
Rootlets to 500mm

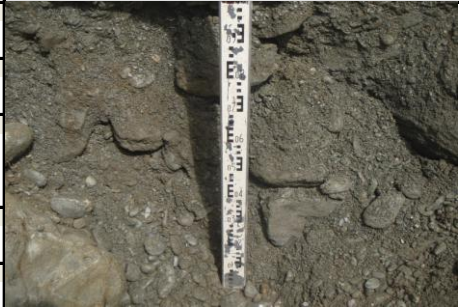
FROM (m): <u>0.2</u> TO (m): <u>1.5</u>				Photo

<small>TERTIARY COMPONENT</small>		<small>SECONDARY COMPONENT</small>			<small>PRIMARY COMPONENT</small>
		Sandy			Gravel
<small>MODIFIER</small>	<small>MINOR COMPONENT</small>				<small>PLASTICITY</small>
with	Boulders & cobbles				non
<small>PARTICLE SIZE</small>		<small>MODIFIER</small>	<small>PARTICLE SIZE</small>		
Med sand		to	Coarse sand		
Fine gravel		to	Coarse gravel		
<small>PARTICLE SHAPE</small>		<small>MODIFIER</small>	<small>PARTICLE SHAPE</small>		
Sub angular		to	Sub rounded		
<small>COLOUR 1</small>		<small>COLOUR 2</small>		<small>MOISTURE</small>	
grey				Moist	
<small>CONSISTENCY / DENSITY</small>		<small>MODIFIER</small>	<small>CONSISTENCY / DENSITY</small>		
loose					
<small>ADDITIONAL COMMENTS</small>					
Boulders up to 800mm in size.

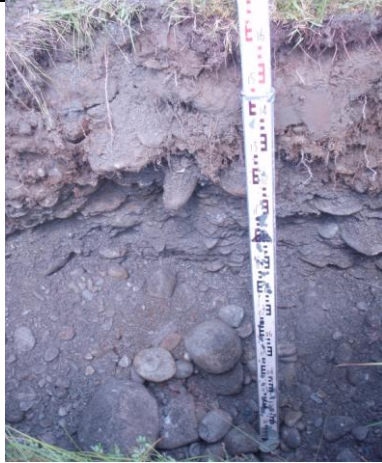
FROM (m): <u>0</u> TO (m): <u>0.3</u>				Photo

TERTIARY COMPONENT		SECONDARY COMPONENT			PRIMARY COMPONENT
					Silt
MODIFIER	MINOR COMPONENT				PLASTICITY
					non
PARTICLE SIZE		MODIFIER	PARTICLE SIZE		
Fine					
PARTICLE SHAPE		MODIFIER	PARTICLE SHAPE		
COLOUR 1		COLOUR 2			MOISTURE
Brownish		Grey		moist	
CONSISTENCY / DENSITY		MODIFIER	CONSISTENCY / DENSITY		
loose					
ADDITIONAL COMMENTS					
Rootlets to 400mm

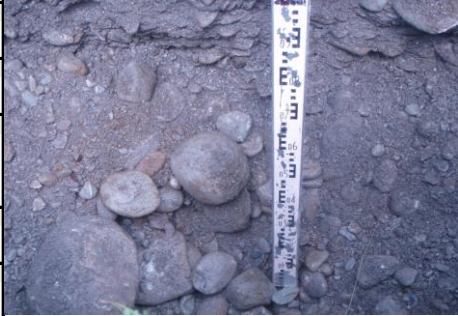
FROM (m): <u>0.3</u> TO (m): <u>1.5</u>				Photo

TERTIARY COMPONENT		SECONDARY COMPONENT			PRIMARY COMPONENT
		Sandy			Gravel
MODIFIER	MINOR COMPONENT				PLASTICITY
with	Boulders & cobbles				non
PARTICLE SIZE		MODIFIER	PARTICLE SIZE		
Med sand		to	Coarse sand		
Fine gravel		to	Coarse gravel		
PARTICLE SHAPE		MODIFIER	PARTICLE SHAPE		
Sub angular		to	Sub rounded		
COLOUR 1		COLOUR 2		MOISTURE	
grey				Moist	
CONSISTENCY / DENSITY		MODIFIER	CONSISTENCY / DENSITY		
loose					
ADDITIONAL COMMENTS					
Boulders up to 600mm in size.

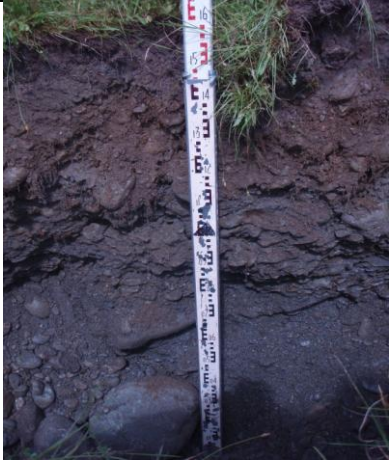
FROM (m): 0 TO (m): 1.6				Photo

TERTIARY COMPONENT		SECONDARY COMPONENT				PRIMARY COMPONENT	
		Sandy				Gravel	
MODIFIER	MINOR COMPONENT					PLASTICITY	
with	Cobbles & boulders					non	
PARTICLE SIZE		MODIFIER				PARTICLE SIZE	
Medium sand		to				Coarse sand	
Fine gravel		to				Coarse gravel	
PARTICLE SHAPE		MODIFIER				PARTICLE SHAPE	
Sub-angular		to				Sub-rounded	
COLOUR 1		COLOUR 2		MOISTURE			
Brownish Grey		grading to grey		moist			
CONSISTENCY / DENSITY		MODIFIER		CONSISTENCY / DENSITY			
loose							
ADDITIONAL COMMENTS							
Rootlets to 600mm Boulders to 500mm in size							
Topsoil grading to gravel over 400mm

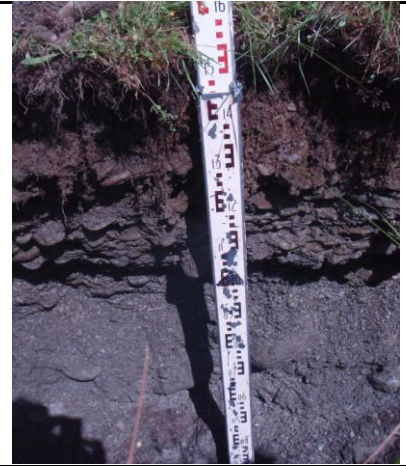
FROM (m): <u>0</u> TO (m): <u>0.6</u>				Photo	
TERTIARY COMPONENT		SECONDARY COMPONENT		PRIMARY COMPONENT	
		<u>Sandy</u>		<u>Gravel</u>	
MODIFIER	MINOR COMPONENT			PLASTICITY	
<u>with</u>	<u>Cobbles</u>			<u>non</u>	
PARTICLE SIZE		MODIFIER		PARTICLE SIZE	
<u>Medium sand</u>		<u>to</u>		<u>Coarse sand</u>	
<u>Fine gravel</u>		<u>to</u>		<u>Coarse gravel</u>	
PARTICLE SHAPE		MODIFIER		PARTICLE SHAPE	
<u>Sub-angular</u>		<u>to</u>		<u>Sub-rounded</u>	
COLOUR 1	COLOUR 2			MOISTURE	
<u>Brownish Grey</u>	<u>grading to grey</u>			<u>moist</u>	
CONSISTENCY / DENSITY		MODIFIER		CONSISTENCY / DENSITY	
<u>loose</u>					
ADDITIONAL COMMENTS					
<u>Rootlets to 400mm Stratified gravel zone</u>					
<u>Topsoil grading to gravel over 200mm</u>

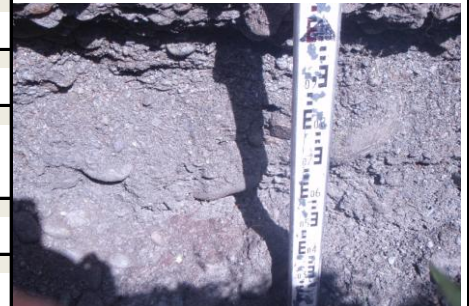
FROM (m): <u>0.6</u> TO (m): <u>1.6</u>				Photo	
TERTIARY COMPONENT		SECONDARY COMPONENT		PRIMARY COMPONENT	
		<u>Sandy</u>		<u>Gravel</u>	
MODIFIER	MINOR COMPONENT			PLASTICITY	
<u>with</u>	<u>Cobbles & boulders</u>			<u>non</u>	
PARTICLE SIZE		MODIFIER		PARTICLE SIZE	
<u>Medium sand</u>		<u>to</u>		<u>Coarse sand</u>	
<u>Fine gravel</u>		<u>to</u>		<u>Coarse gravel</u>	
PARTICLE SHAPE		MODIFIER		PARTICLE SHAPE	
<u>Sub-angular</u>		<u>to</u>		<u>Sub-rounded</u>	
COLOUR 1	COLOUR 2			MOISTURE	
<u>Grey</u>				<u>moist</u>	
CONSISTENCY / DENSITY		MODIFIER		CONSISTENCY / DENSITY	
<u>loose</u>					
ADDITIONAL COMMENTS					
<u>Boulders up to 700mm in size</u>

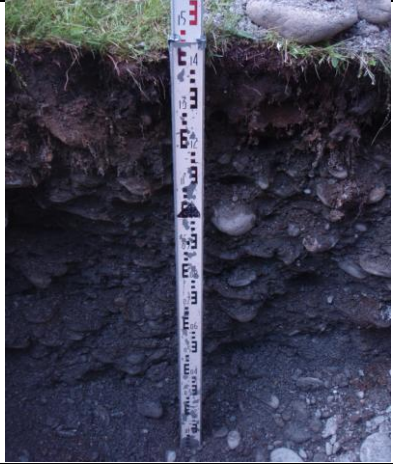
FROM (m): <u>0</u> TO (m): <u>0.6</u>				Photo

TERTIARY COMPONENT		SECONDARY COMPONENT			PRIMARY COMPONENT	
		<u>Sandy</u>			<u>Gravel</u>	
MODIFIER	MINOR COMPONENT				PLASTICITY	
<u>with</u>	<u>Cobbles & boulders</u>				<u>non</u>	
PARTICLE SIZE		MODIFIER			PARTICLE SIZE	
<u>Medium sand</u>		<u>to</u>			<u>Coarse sand</u>	
<u>Fine gravel</u>		<u>to</u>			<u>Coarse gravel</u>	
PARTICLE SHAPE		MODIFIER			PARTICLE SHAPE	
<u>Sub-angular</u>		<u>to</u>			<u>Sub-rounded</u>	
COLOUR 1		COLOUR 2		MOISTURE		
<u>Grey</u>				<u>moist</u>		
CONSISTENCY / DENSITY			MODIFIER		CONSISTENCY / DENSITY	
<u>loose</u>						
ADDITIONAL COMMENTS						
<u>Rootlets to 400mm Boulders to 400mm in size</u>						
<u>Topsoil grading to gravel over 300mm</u>
